Meeting Minutes Transmittal/Approval Unit Managers' Meeting 200 Area Groundwater and Source Operable Units 1200 Jadwin, Richland, Washington July 18, 2007

HARD COPY DISTRIBUTION UNIT MANAGERS' MEETING, 200 AREA GROUNDWATER SOURCE OPERABLE UNITS July 18, 2007

200 AREA UNIT MANAGERS' MEETING DRAFT AGENDA

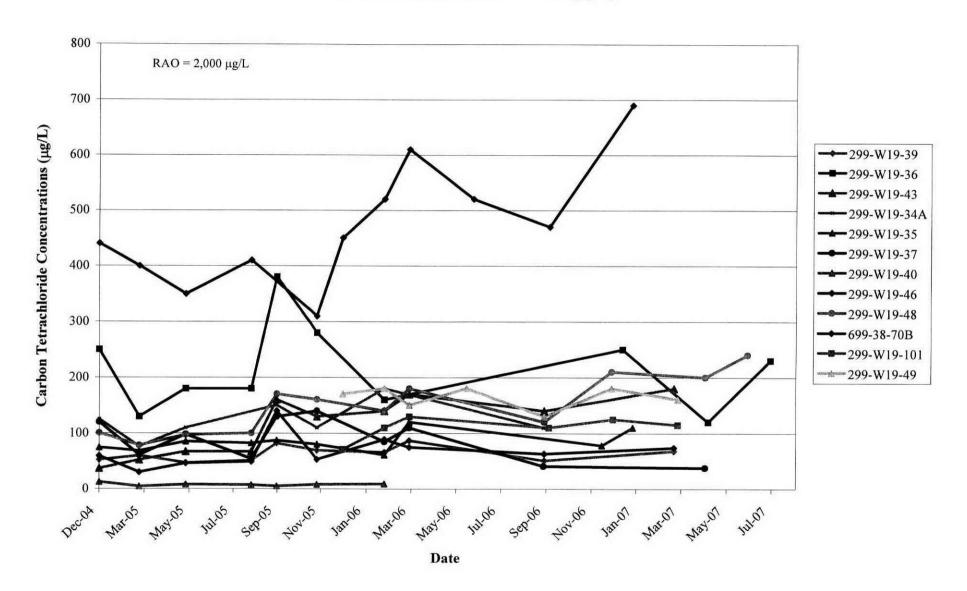
Comparison of Maximum Carbon Tetrachloride Rebound Concentrations Monitored at 200-PW-1 Soil Vapor Extraction Sites FY 2003 - FY 2007

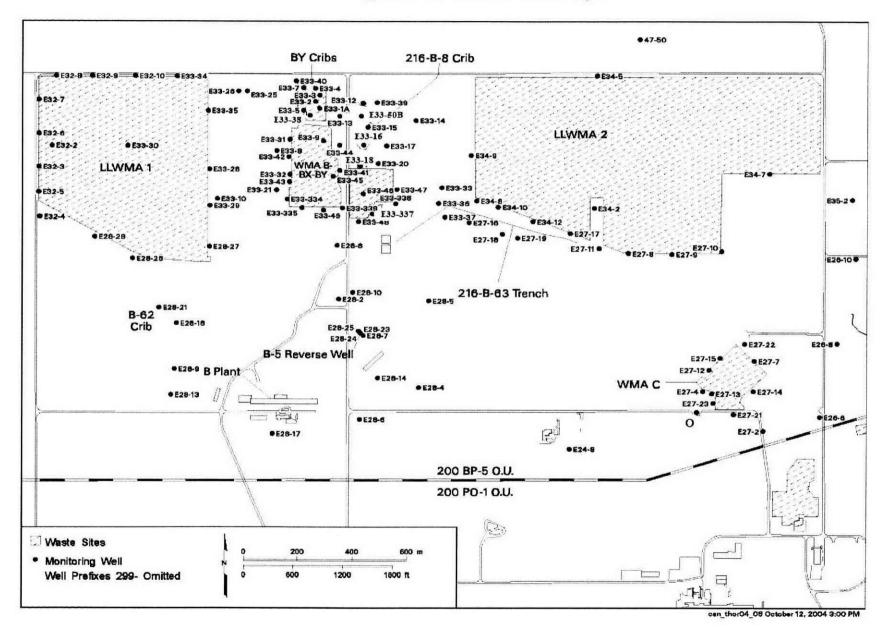
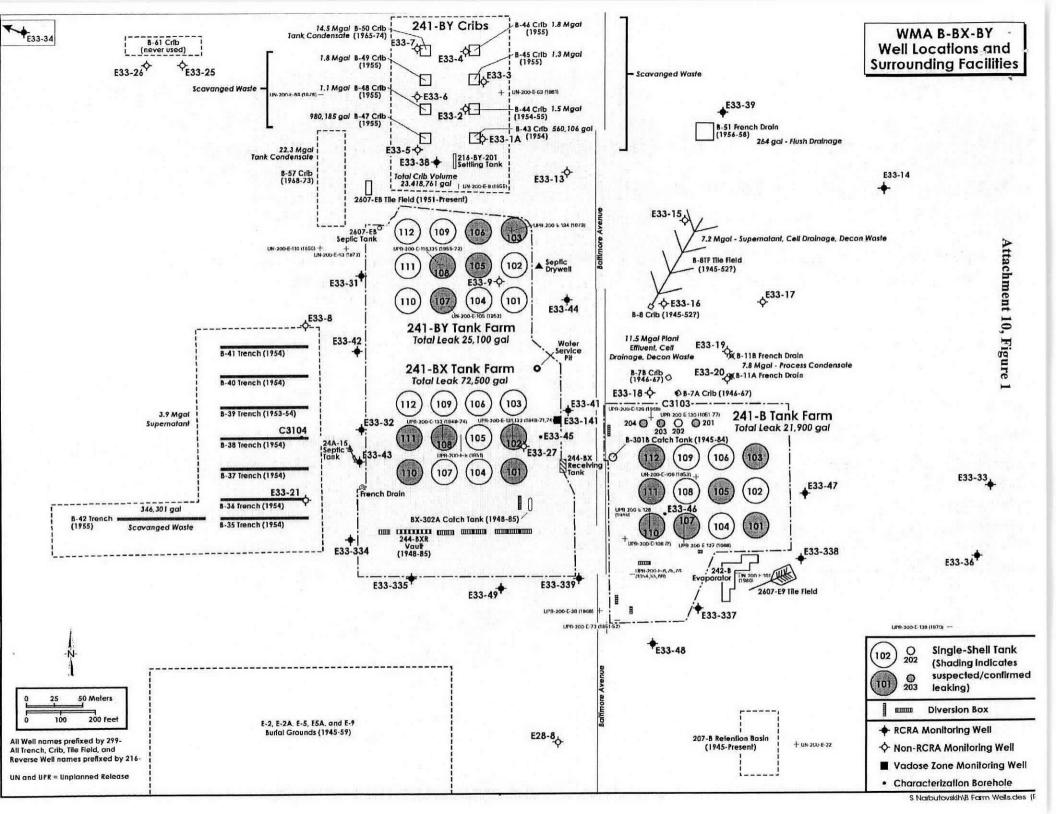
Figure 1: "O" Well Location Map.

- EPA has approved the O well for drilling this summer (see Figure 1, **Attachment 9**).
- FH has recommended to EPA and DOE to wait on drilling the G well until further groundwater samples are collected from proximal wells in the confined aquifer.
- FH has provided DOE a transport flow presentation for the Tc-99 plume north of the 200 East Area which provides rationale for drilling the N well. A presentation with EPA is scheduled for July 25 to discuss approval of this well location.
- Currently working the excavation permits, waste DQO, and Description of Work for the N and O wells.
- Revising BP-5 Waste Control Plan for the two wells.
- Drilling is scheduled to start early August.

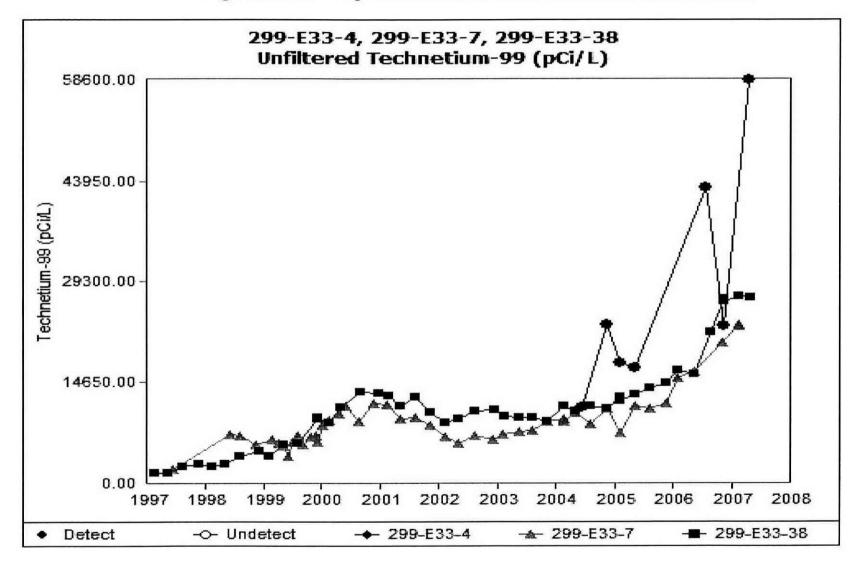
Figure 2: Increasing Technetium-99 concentrations under the BY cribs.

- Tc-99 concentrations continue to increase in the wells under the BY cribs (see Figure 2 **Attachment 10**).
- Recent uranium concentrations have leveled and decreased in the well 299-E33-34 which is out of trend with wells 299-E33-38 and 299-E33-36 (see Figure 3,

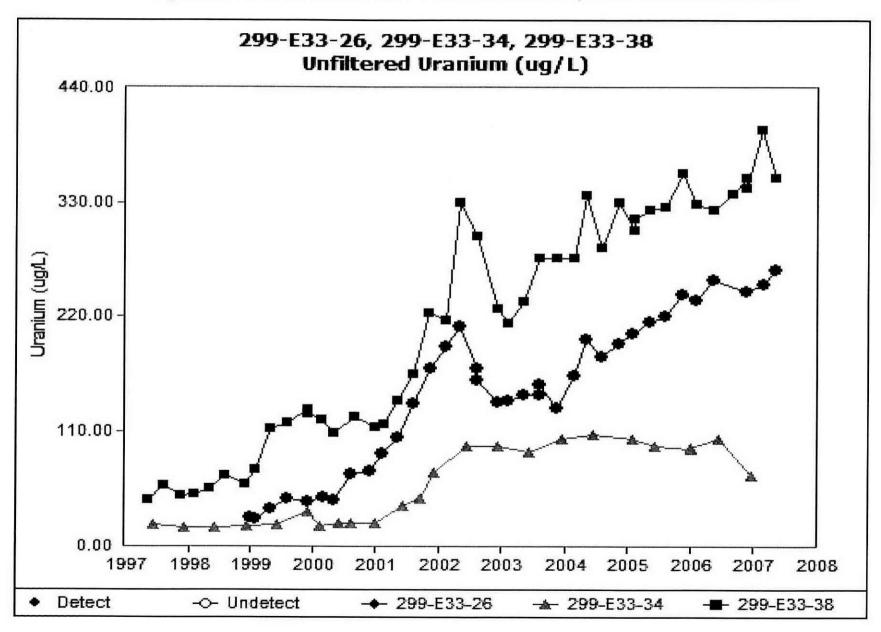
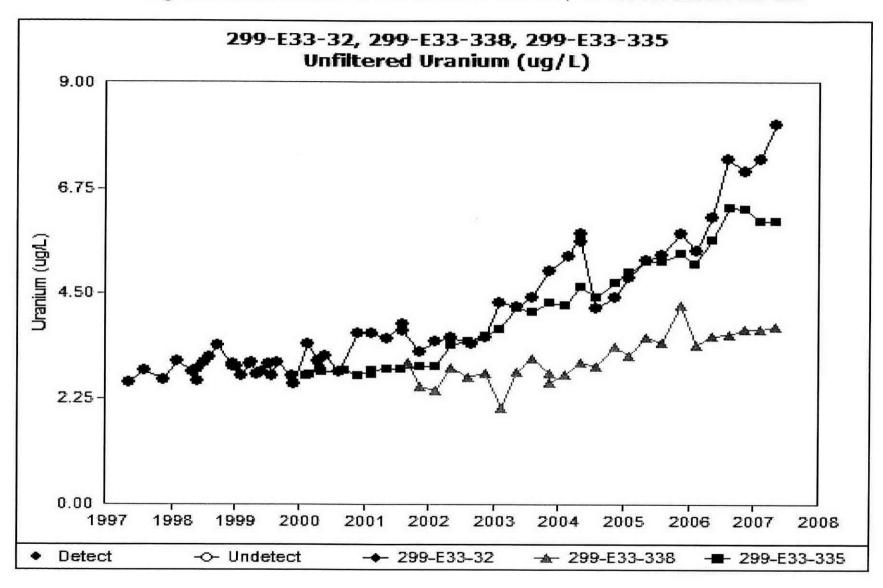
Figure 3: Uranium trend for northwest wells 299-E33-38, 299-E33-26 and 299-E33-34.

Attachment 11). Note that this well had been used to portray a northwest flow direction.

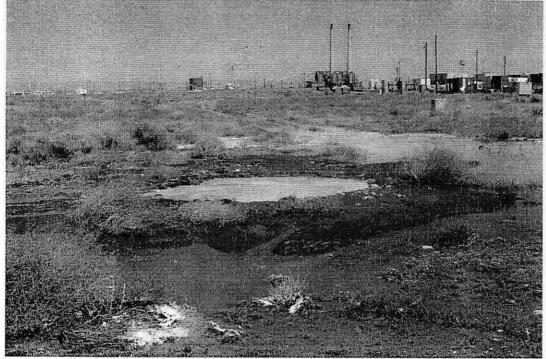
Figure 1. Raw Water Leak, Looking North

A truck filling evolutions normally take approximately 10 minutes. After 15 minutes with no decrease in flow, the operator contacted the Distribution Supervisor and informed him of a potential Raw Water line failure in 200 West. The Distribution Supervisor contacted several operators in the field and had them commence a drive down of Raw Water lines in the 200 West Area. The leakage was noted on the west side of U-Plant and the Raw Water line was isolated and the leak stopped at 12:14 pm (see Figure 1)

It was determined that the leakage came from a 12" ductile Raw Water line that had been cement lined during Project L-397. It is suspected that a 6 " hot tapped connection, that was installed approximately 2 years ago to convert potable water supplies to 2 fire hydrants over to Raw Water, may have failed.

- Stop the leak (completed)
- Notify project personnel and regulators (completed)
- Conduct a radiological survey of the area (completed no contamination found)
- Install data logger on well 299-W19-18 (schedule for this week)
- Evaluate neutron probe measurements on well 299-W19-18 (next couple weeks)
- Fix raw water pipe (next couple weeks)
- Re-slope eroded areas (coming week)
- Evaluate need to berm or re-contour areas near major contamination (coming months)

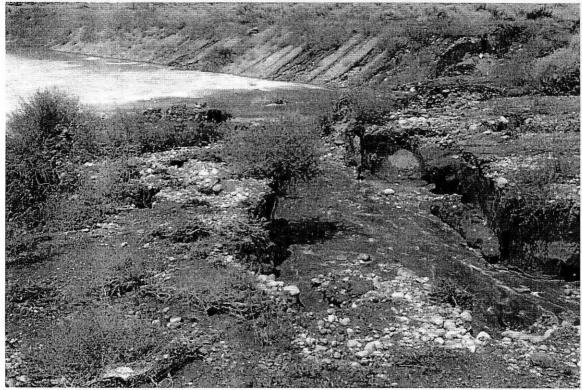
Figure 2. Water Flowing into the 2607-W5 Sanitary Tile Field

Approximately 458,440 gallons of Raw Water was leaked to the surrounding ground, with the majority of that going into the abandoned 2607-W5 Sanitary Sewer Tile Field. (See Figure 2)

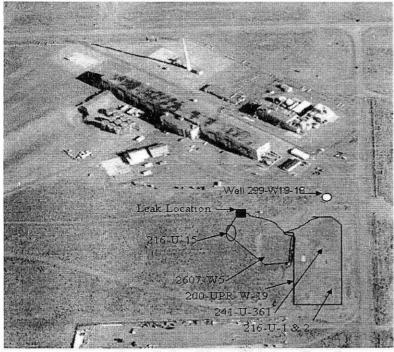
Figure 3. Raw Water Leak Area (Locations are approximated)

This area is north of 16th Street. It is estimated that the water covered less then 2 acres (See Figure 3, Leak area is denoted by blue shading).

Based on the fact that the leak occurred near several UW-1 waste sites, it is important to evaluate the potential impacts to these sites. In general, there were no apparent surface impacts to any waste site due to erosion even though the impacted area encompassed the 216-U-15 waste site.

No pooling occurred on the 216-U-15 waste site. The amount of water introduced to the waste site is believed to be no more than that introduced by winter snow melt based on soil condition observations roughly two hours after the event.
